# Effect of Open Dumping of Municipal Solid Waste on Groundwater Quality in Ekurede Itsekiri, Warri South LGA, Delta State, Nigeria.

## Abstract

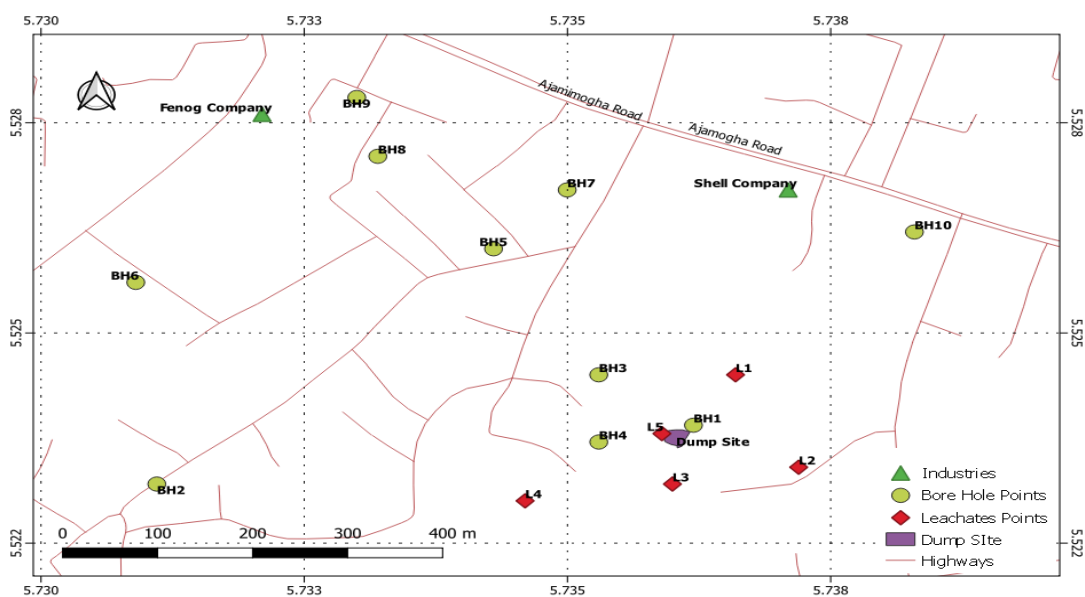
**Figure 2:** Map of the Study Area Showing the Sampling Points (both for Groundwater and Leachate)

Ten borehole samples were collected at distances between the ranges of 60-230m from an open dumpsite in the study area (Table 1 and Figure 2). Also, five leachate samples were collected randomly from five different leachate points (L1, L2, L3, L4 and L5) around the dumpsite (Figure 2). These samples were collected using 1l plastic bottles in May, 2021 (rainy season). The sample bottles were properly cleaned, sterilized before use and they

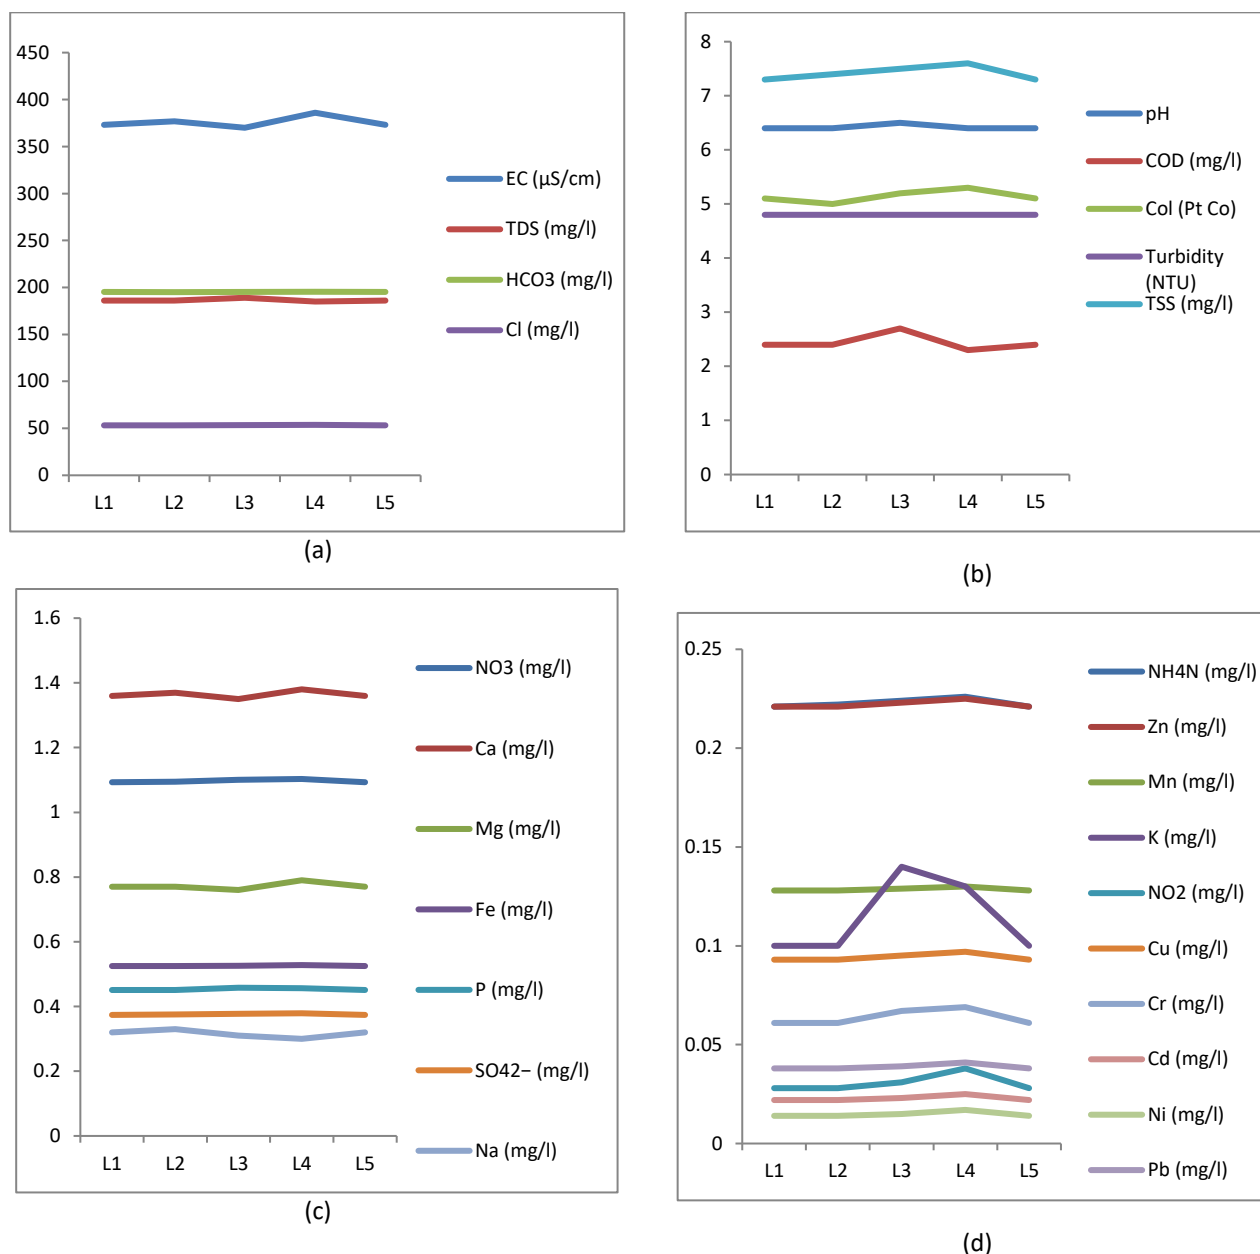
**Figure 3:** Variations of the Physicochemical Properties of Leachate Samples at Different Points around the Dump Site

Results from Table 3 and Figure 3 shows that all parameters examined were within WHO and NDSWQ acceptable limits for drinking water quality standards except for pH, coliform bacteria (Col.), Fe, Cr, Cd, Pb and that there were slight variations in parameters at different leachate points. According to Vasanthi *et al.* (2008) the amount and production rates of contaminants depend on the type of waste and moisture content. Hence, the slight variation observed in parameters might be due to the type of waste and moisture content at different leachate points and this is implying that the waste dumped at different points in the dump site might not have much effect on the leachate at different points. The mean pH value (6.42) of the leachate was below the acceptable limits of 6.5-8.5 (WHO, 2011 and NSDWQ, 2015) and it indicates slightly acidic leachate. From Figure 3b, the pH of leachate from L3 (6.5) was within acceptable limits while the pH of leachate from L1, L2, L4 and L5 (6.4 respectively) were not within acceptable limits. The acidic pH observed may be attributed to the carbon dioxide produced from the dump site which is as a result of the decomposition of the Organic matter contained in the refuse under aerobic conditions. It is

The mean coliform count (5.14pt.co) was above the acceptable limit of 0pt.co (WHO, 2011 and NSDWQ, 2015). Results from Figure 3b indicates that the highest count (5.3pt.co) was recorded in leachate from L4, left side of the dumptsite while the lowest count (5.0pt.co) was recorded in L2, right side of the dumptsite. Other researchers (Achadu *et al.*, 2018) have also reported the presence of coliform bacteria in the leachate from an open dump site in Nigeria. The presence of coliform bacteria in the leachate implies that the dump site consist of both animal and human waste (particularly from waste pickers who defecate at the site). And this poses a threat to the groundwater quality around the dump site as the leachate might contaminate the groundwater with time, thus making it unsafe and unfit for human use.

The mean values of Fe (0.5258 mg/l), Cr (0.0638 mg/l), Cd (0.0228 mg/l) and Pb (0.0388 mg/l) were all above the acceptable limits of 0.3 mg/l, 0.05 mg/l, 0.003 mg/l and 0.01 mg/l (WHO, 2011 and NSDWQ, 2015). From Figure 3c and 3d, the highest Fe, Cr, Cd and Pb values (0.528 mg/l, 0.069 mg/l, 0.025 mg/l and 0.041 mg/l) were recorded in leachate from L4. High levels of heavy metals (Fe, Cr, Cd and Pb) observed in the leachate is in accordance with those of Achadu *et al.* (2018). Their presence may originate from the different waste materials dumped at the site (Aderemi *et al.*, 2011). The presence of high concentrations of Fe, Cr, Cd and Pb may be greatly influenced by the disposal of scrap metals (such as iron metals, stainless steel etc.), PVC plastics and lead pipes at the site. High levels of Cd and Pb may also be an indication of battery wastes at the dump site. The high concentrations of heavy metals (Fe, Cr, Cd and Pb) in the leachate calls for concerns as it might contaminate the groundwater around the dump site with time.

Results from Figure 3 and 4 further indicated that all the parameters analysed were higher in concentrations in the groundwater than the leachate, except for coliform bacteria, Fe, Mn, Zn, Cu, Cr, Cd, Ni and Pb which were higher in the leachate than the groundwater. It implies that the leachate is a potential threat of faecal and heavy metal contamination to the groundwater with time. Hence, the dump site has impact on the groundwater quality in the study area.

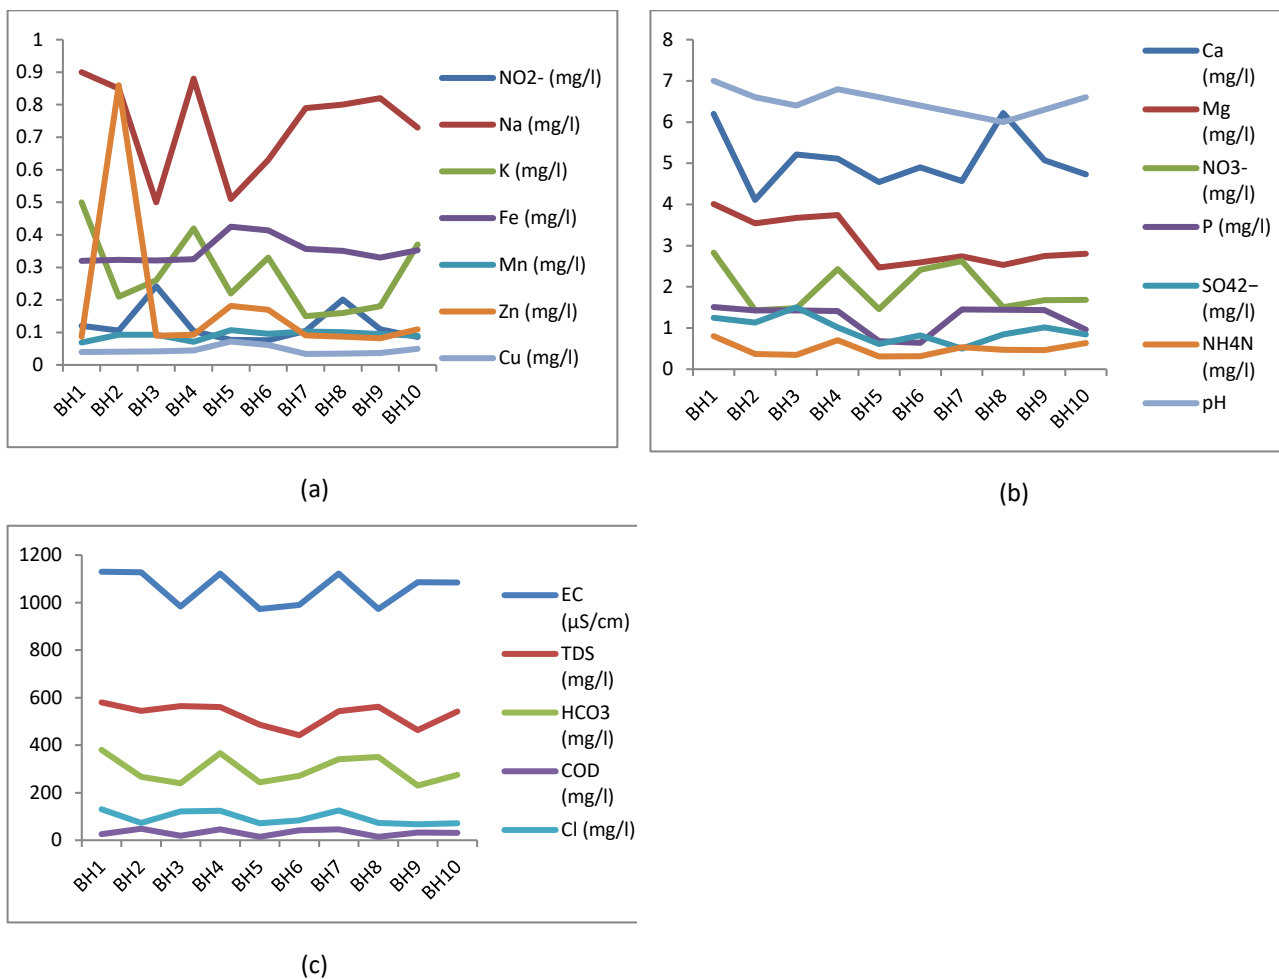
**Figure 4:** Variations of Physiochemical Properties of Groundwater Samples at Different Locations from the Dump Site

Results from Table 4 and Figure 4 shows that all parameters examined were within WHO and NSDWQ acceptable limits for drinking water quality standards except for pH, TDS, NH<sub>4</sub>N and Fe and that there were variations in parameters at different groundwater locations. The mean pH value (6.49) was not within acceptable limits of 6.5-8.5 (WHO, 2011 and NSDWQ, 2015) and it indicates slightly acidic water. However, the pH of the groundwater at different locations from the dump site (Figure 4b) revealed moderately acidic to neutral water, as pH of water from locations BH1, BH2, BH4, BH5 and BH10 (7.0, 6.6, 6.8, 6.6 and 6.6 respectively) were within acceptable limits while the pH of water from locations BH3, BH6, BH7, BH8 and BH9 (6.4, 6.4, 6.2, 6.0.and 6.3 respectively) were not within acceptable limits. Water from BH1 at 60m from the dump site has the highest pH of 7.0 (neutral water) while water from BH8 at 200m from the dump site has the lowest pH of 6.0 (moderately acidic). The acidic nature of Nigerian groundwater at distances from an open dump site had been noted by various researchers (Akudo *et al.*, 2010; Aderemi *et al.*, 2011; Kola-Olusanya, 2012 and Achadu *et al.*, 2018). Acidity in ground water may be as a result of the presence of free carbon dioxide. Hence, the moderately acidic to neutral nature of the groundwater observed in this study might be attributed to the methanogenic activity in the dump site leachate (as it permeates into the underground) together with the hydrogeological condition of the area (presence of calcareous material in soils and rocks). Acidity enhances the corrosive characteristics of water which may result in deterioration of distribution

The mean TDS value (528.7 mg/l) was above the acceptable limit of 500 mg/l (NSDWQ, 2015), however TDS were below and above acceptable limit at different groundwater locations (Figure 4c). The TDS in water from location BH5, BH6 and BH9 (486 mg/l, 442 mg/l and 463 mg/l respectively) were below acceptable limits while TDS in water from location BH1, BH2, BH3, BH4, BH7, BH8 and BH10 (580 mg/l, 544 mg/l, 564 mg/l, 561 mg/l, 543 mg/l, 562 mg/l and 542 mg/l respectively) were above acceptable limits. The highest concentrations of TDS were observed at BH1 (580 mg/l), BH3 (564 mg/l) and BH8 (562 mg/l) which are 60 m, 100 m and 200 m from the dump site respectively. Higher levels of TDS in groundwater around dump sites in Warri town have also been noted by Akudo *et al.* (2010). Although, the TDS in the leachates were all below acceptable limit, however, the higher levels of TDS observed may be attributed to the permeation of leachate from the dump site together with effluents from the industries around the areas (Ibe-Sr *et al.*, 1999). It also implies a downward transfer of leachate into the groundwater (Mor *et al.*, 2006; Longe and Enekwechi, 2007; Srigirisetty *et al.*, 2017). Higher levels of TDS in water decrease its palatability and may possibly cause gastro-intestinal irritation in human and laxative effects particularly upon transits (WHO, 1997; Srigirisetty *et al.*, 2017).

Although the mean NH<sub>4</sub>N value (0.4949) was below the acceptable limit of 0.5 mg/l (NSDWQ, 2015), however NH<sub>4</sub>N were below and above acceptable limit at different

groundwater locations (Figure 4b). The  $\text{NH}_4\text{N}$  in water from locations BH2, BH3, BH5, BH6, BH8 and BH9 (0.370 mg/l, 0.345 mg/l, 0.310 mg/l, 0.320 mg/l, 0.475 mg/l and 0.460 mg/l respectively) were all below acceptable limits while the  $\text{NH}_4\text{N}$  in water from locations BH1, BH4, BH7 and BH10 (0.803 mg/l, 0.705 mg/l, 0.530 mg/l and 0.631 mg/l respectively) were above acceptable limits. The highest  $\text{NH}_4\text{N}$  value (0.803 mg/l) was recorded in water from BH1. Izeze and Konboye (2018) have also reported higher levels of  $\text{NH}_4\text{N}$  in groundwater in Warri town. Higher levels of  $\text{NH}_4\text{N}$  observed in this study are an indication of faecal contamination. Although, the  $\text{NH}_4\text{N}$  in the leachates were all below acceptable limit, however the high content of  $\text{NH}_4\text{N}$  in the groundwater might be attributed to the leachate from the dump site (due to the presence of coliform bacteria in the leachate) together with possible septic tank leakage within the areas (Izeze and Konboye, 2018). Ammonia in water is an indicator of possible bacterial, sewage and animal waste pollution (WHO, 2011), thus rendering the water unsafe and unfit for human use as it may result in serious health issues such as water borne diseases (typhoid fever, cholera, and dysentery etc.).

The mean Fe value (0.351 mg/l) was above the acceptable limit of 0.3 mg/l (WHO, 2011 and NSDWQ, 2015). From Figure 4a, It was observed that the Fe content in the groundwater at all locations were all above the acceptable limits (BH1-0.32 mg/l; BH2-0.323 mg/l; BH3-0.321 mg/l; BH4-0.325 mg/l; BH5-0.425 mg/l; BH6-0.414 mg/l; BH7-0.357 mg/l; BH8-0.351 mg/l; BH9-0.33 mg/l; BH10-0.353). The highest concentrations of Fe were observed at BH5 (0.425 mg/l) and BH6 (0.414 mg/l) which are at 150 m and 220 m from the dump site. Similarly, high Fe content in groundwater within and around the vicinity of a dump site has also been reported (Akudo *et al.*, 2010; Ugwu and Nwosu, 2009; Aderemi *et al.*, 2011). The high content of Fe in this study may be attributed to the permeation of leachate from the dump site together with the soil geology of the study area (Oghenero *et al.*, 2014). Higher concentrations of Fe in water can result to hemochromatosis, heart diseases, liver problems and diabetes (Garvin 2017; Egun and Ogiesoba-Eguakun, 2018). It also results in aesthetic, taste and odour problems.
